OPERATING EXPERIENCE WEEKLY SUMMARY

Office of Nuclear and Facility Safety

October 2 - October 8, 1998

Summary 98-40

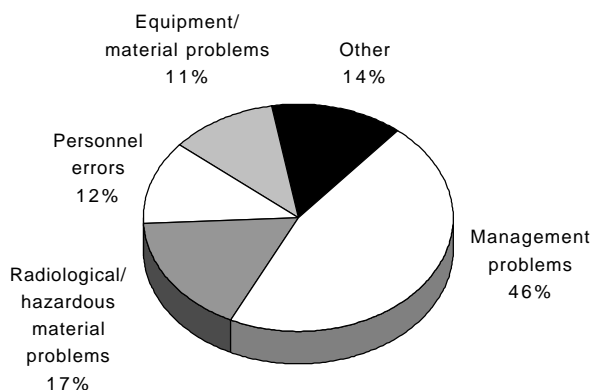
OEAF engineers searched the ORPS database for events that involved a loss of control of radioactive material or spread of contamination from January 1990 to the present and found 3,494 occurrences. Figure 1-1 shows the distribution of root causes. Managers reported 46 percent of the root causes as management problems and 17 percent as radiological/hazardous material problems. Of the management problems, 52 percent were reported as due to inadequate administrative control. Of the radiological/hazardous material problems, 77 percent were reported as legacy contamination events.

Figure 1-1. Root Causes of Loss of Control of Radioactive Material Events¹

These events emphasize the importance of strong radiological control programs and how the lack of effective oversight and work planning can affect worker safety. Line managers are responsible for adequate planning and control of work activities. They should ensure that work control processes are followed and contamination mechanisms are planned for and evaluated. Management and integrating contractors need to closely supervise subcontractors that perform construction and maintenance work at DOE facilities. They should ensure that subcontractor personnel have completed the required training and understand all hazards associated with the job and the workplace. Management and integrating contractors should also provide safety oversight of subcontractor administrative controls, safety programs, and work plans to ensure that subcontractor personnel work safely and in a safe environment.
